Richland-Hyatt-Raccoon Creeks Restoration Project

319 Program Grant Final Report

March 2013

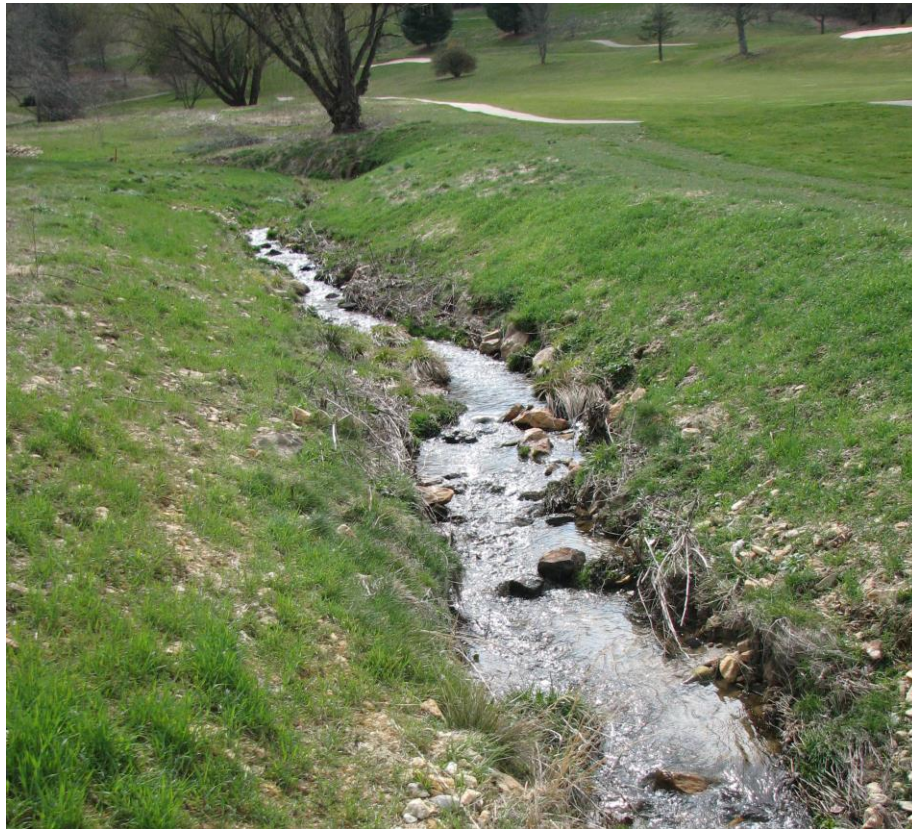
Photo 4. Farmers Branch (Project #1; note: additional riparian trees and shrubs to be planted in spring 2013)

- Total = 3,428 lf.
- Project #1 (Farmers Branch) = 2,400 lf.

Results: The data indicate high total suspended sediment (TSS) concentrations and turbidity during rain events (Table 3). Reductions in sediment loads were noted as TSS was reduced 11.3% and turbidity 39.3%. The original goals were 50% reduction for both parameters. However, the project was completed out of the growing season. Once the vegetation is full established, they will provide additional stability to the streambanks and further reduce sediment loads to Farmers Branch.

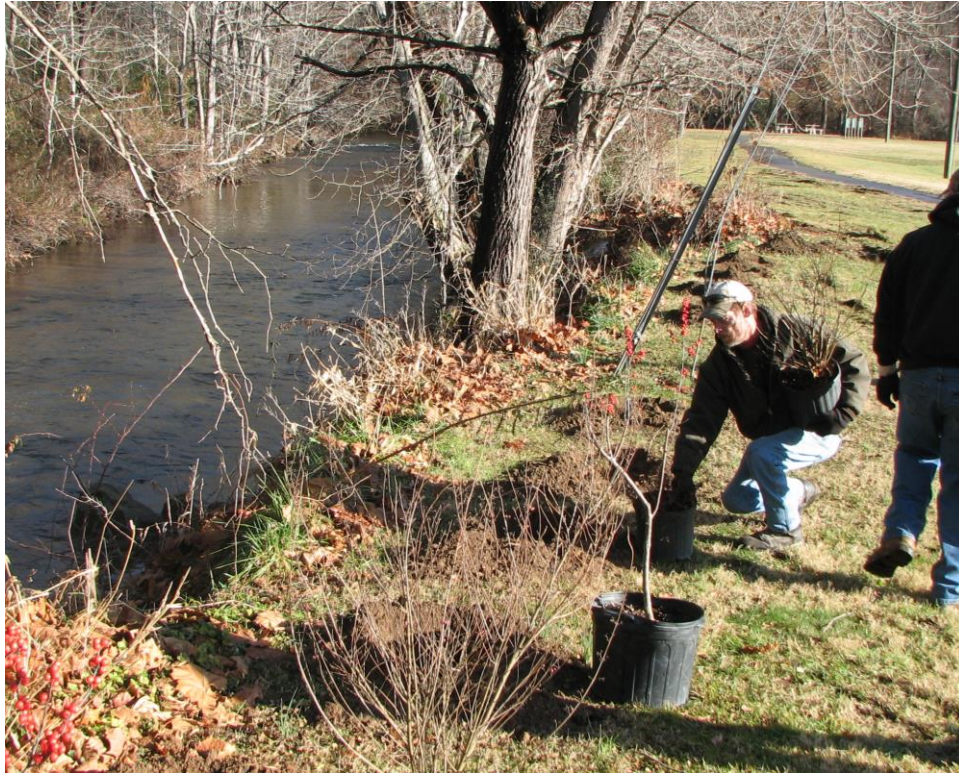
Photo 5. Richland Creek riparian plantings (Project #2)

- Total = 4,628 linear lf.
- Project #1 (Farmers Branch) = 2,400 lf.
- Project #2 (business along Richland Creek) = 1,200 lf.
- Project #3 (Shelton Branch) = 1,028 linear feet. This project differed from the original grant application. Projects #3 and #4 in that application did not occur; those projects would have planted 520 linear feet of riparian vegetation. After the 319 grant was submitted, the town expedited those projects to take advantage of available resources. The partnership then identified one replacement location along Shelton Branch.

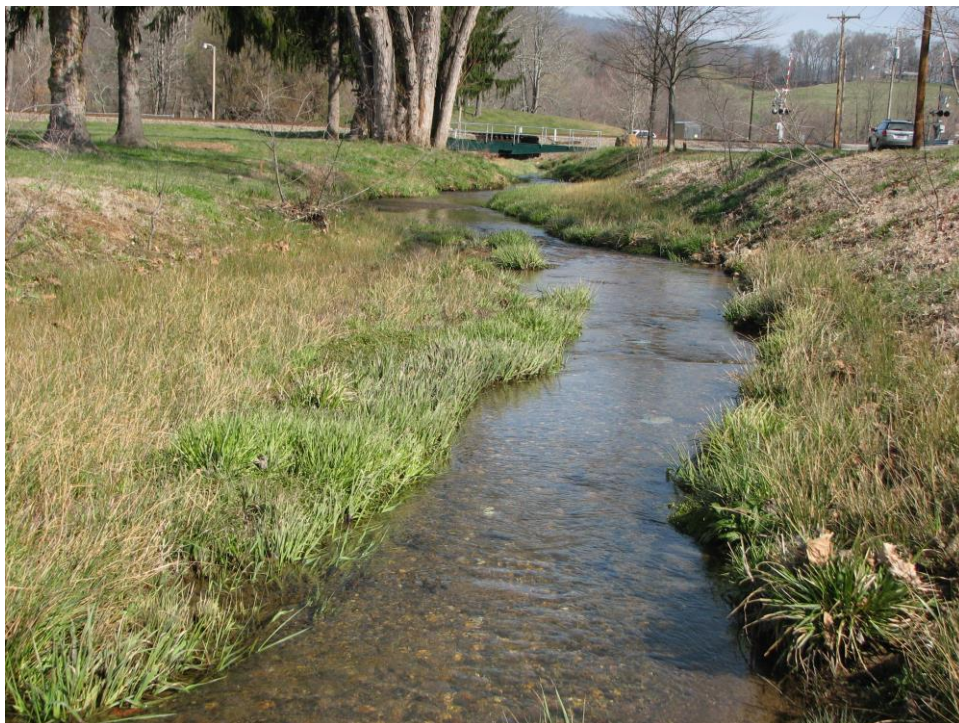
Photo 6. Shelton Branch (Project #3)

- Project #3 (Shelton Branch) = 1,028 lf. This project differed from the original grant application. Projects #3 and #4 in that application did not occur; those projects would have planted 520 linear feet of riparian vegetation. After the 319 grant was submitted, the town expedited those projects to take advantage of available resources. The partnership then identified one replacement location along Shelton Branch.

- Total = 2,628 lf
- Project #1 (Farmers Branch) = 1,600 lf.
- Project #3 (Shelton Branch) = 1,028 lf of instream benches and slope modifications; also included 500 gallon cistern to help control storm water runoff from town maintenance building. This project differed from the original grant application. Projects #3 and #4 in that application did not occur; those projects would have planted 520 linear feet of riparian vegetation. After the 319 grant was submitted, the town expedited those projects to take advantage of available resources. The partnership then identified one replacement location along Shelton Branch.

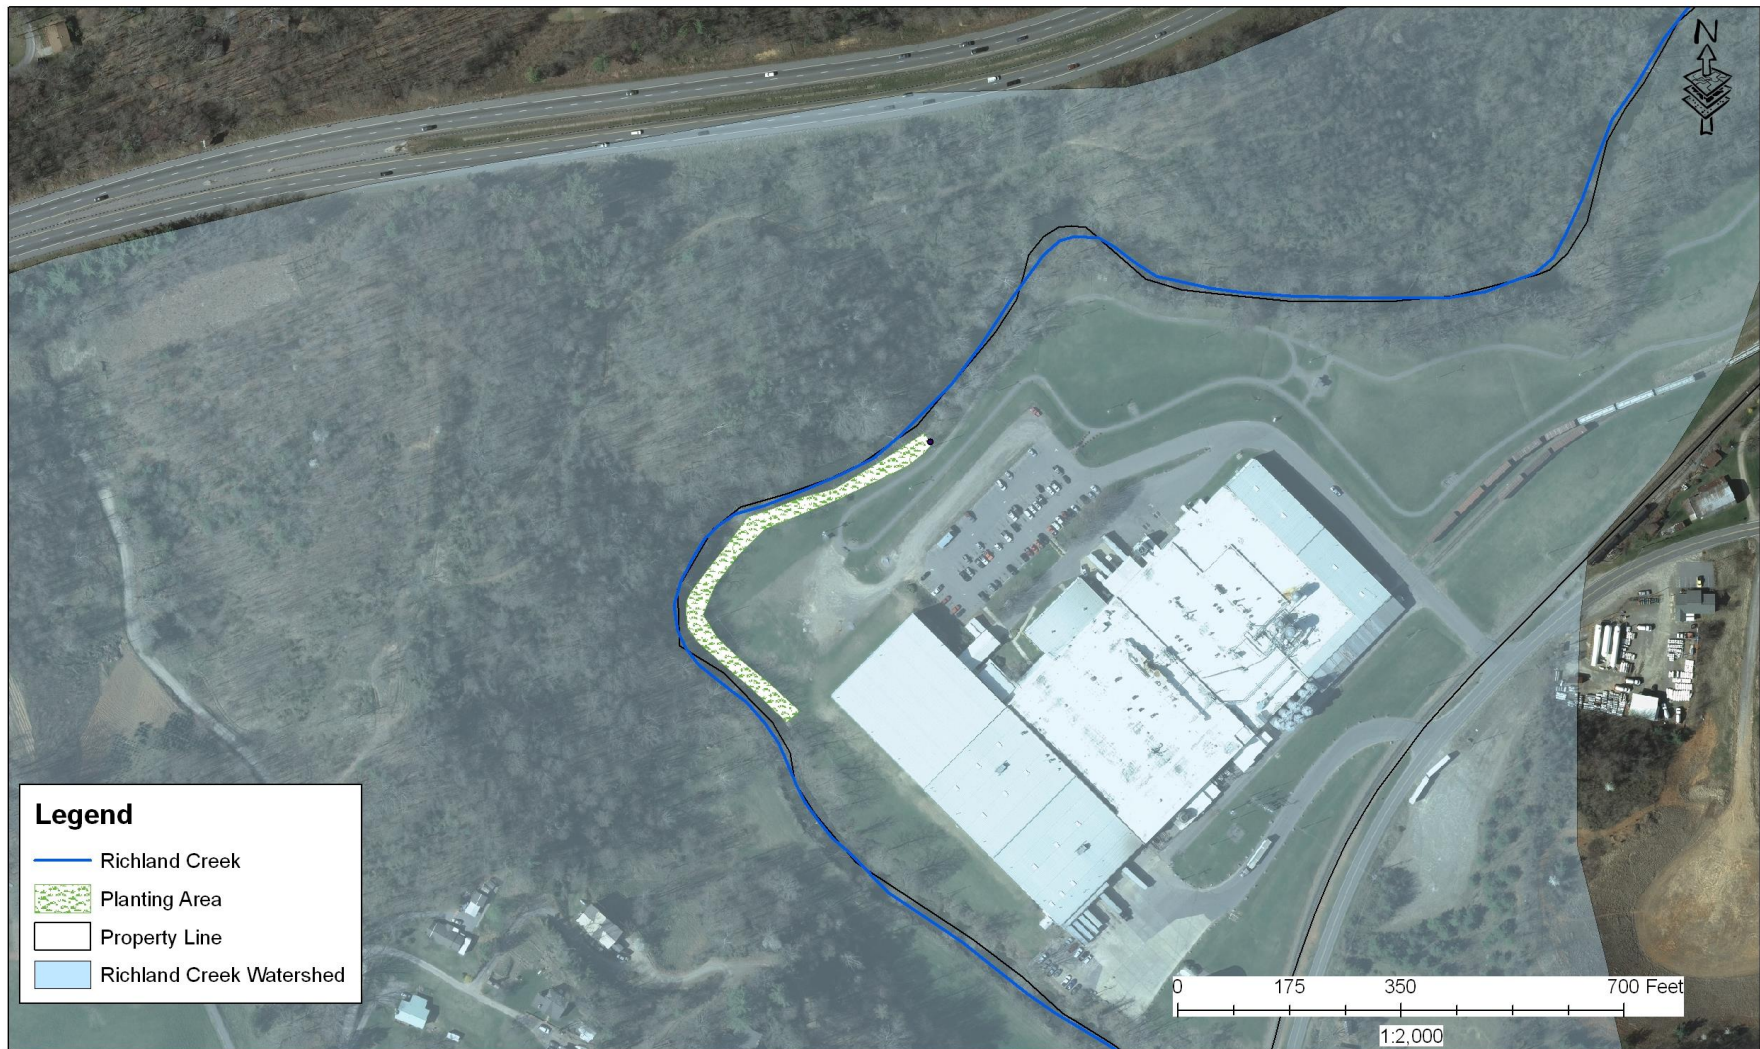
Figure B-2. Richland Creek Riparian Plantings (Project #2)

Watershed Acreage- 4,623.2

Three stream restoration projects were completed. Information for each is found in Table 1 and site maps are found in Appendix B. In addition, multiple septic repairs were completed throughout the watershed.

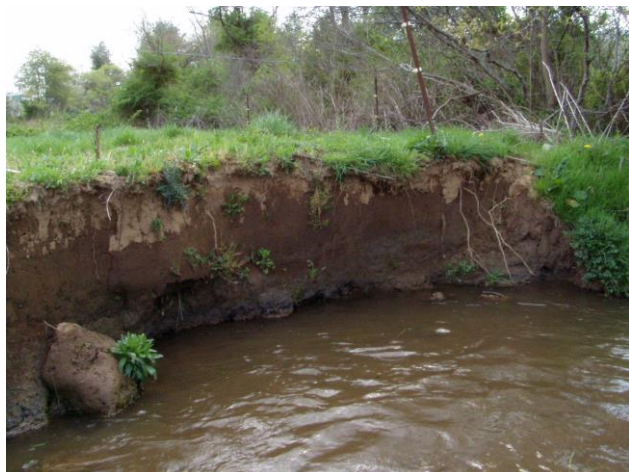
Eroding streambanks

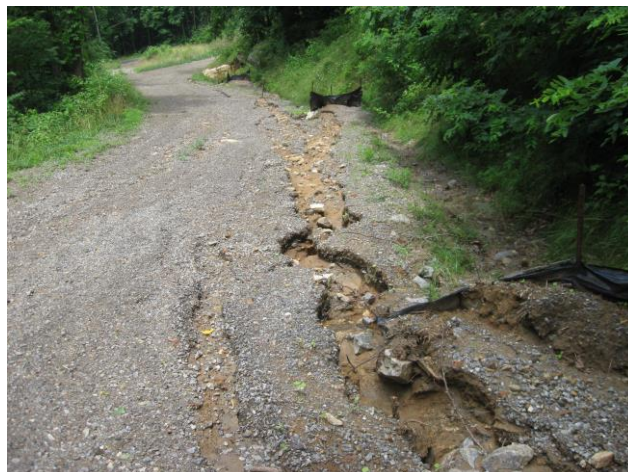
Channelization and inadequate riparian buffers

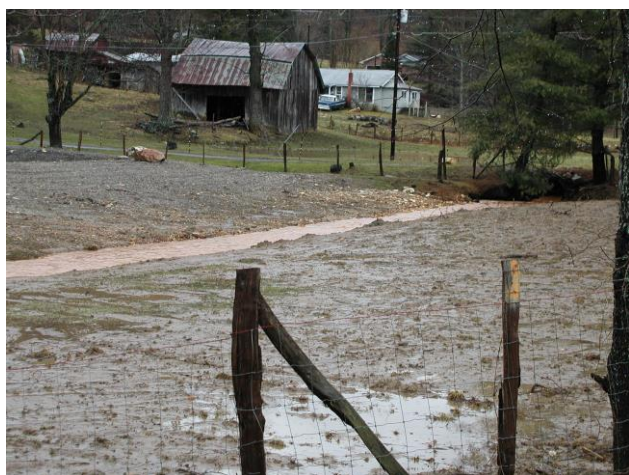
Poor pasture and animal access

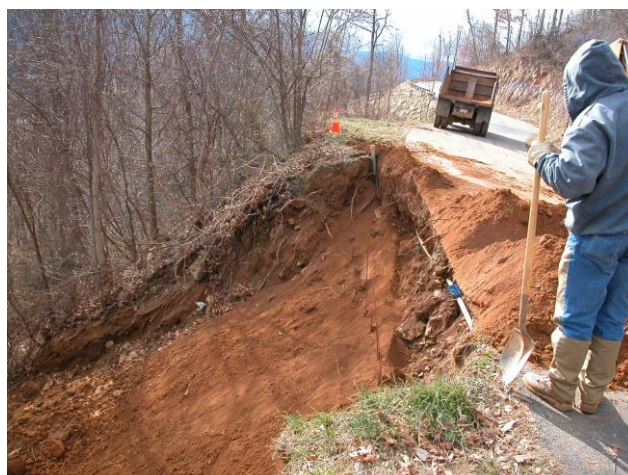
Landslides

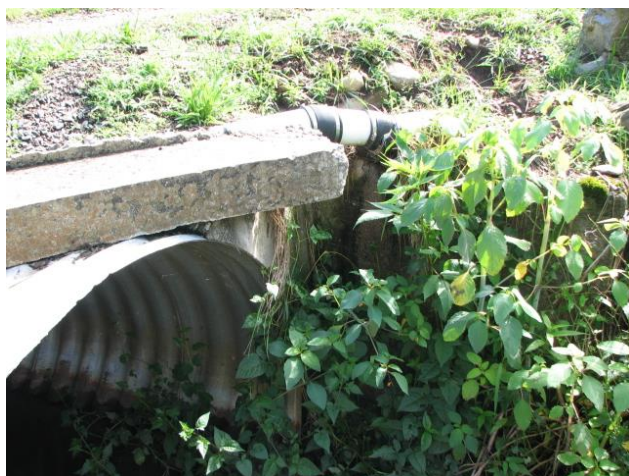
Wastewater infrastructure

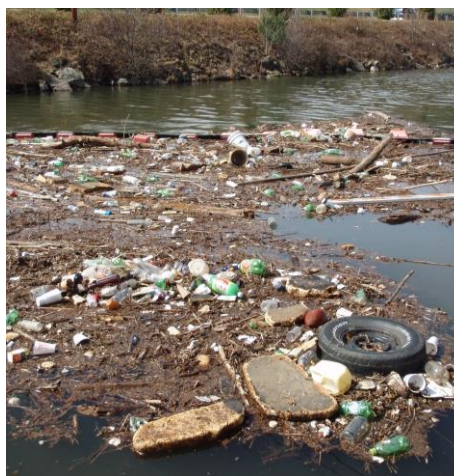
Stormwater and litter
