CT DEPARTMENT OF ENERGY AND ENVIRONMENTAL PROTECTION

CT Pawcatuck River Watershed Bacteria TMDL

FB Environmental and CT DEEP

9/18/2014

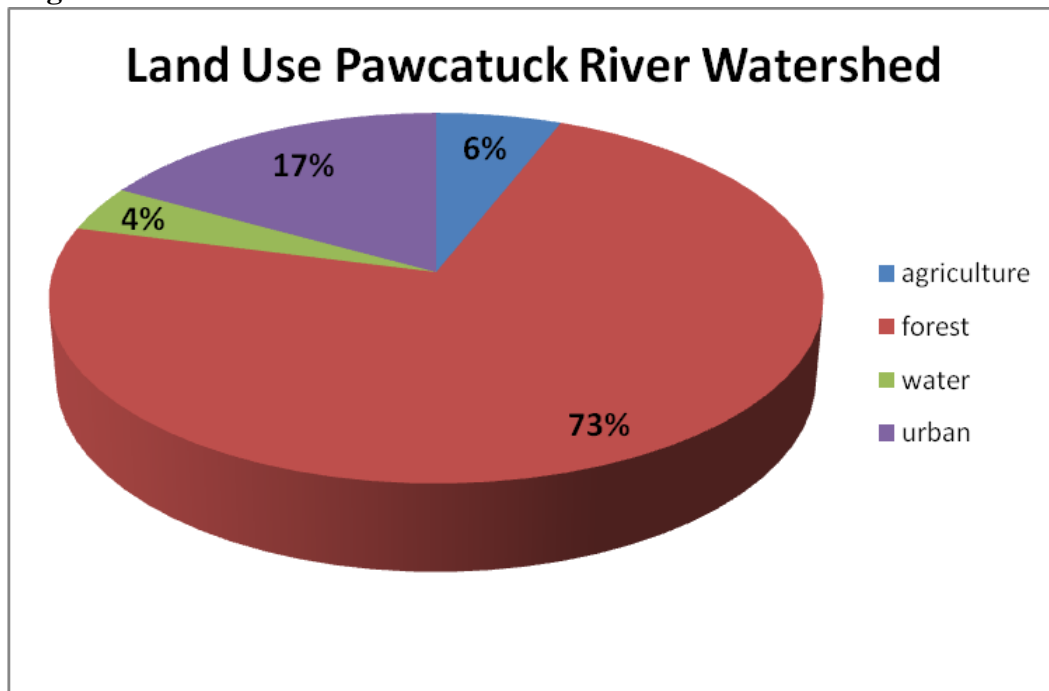
Figure 6: Land uses within the entire Pawcatuck River watershed

As shown in Figures 6 and 7, the Pawcatuck River watershed consists of 17% urban area, 73% forest, 6% agriculture, and 4% water. The majority of the watershed is comprised of forested land use. This is due to heavy forested land use in the Rhode Island portion of the watershed closer to the headwaters of the watershed. The lower part of the watershed, in both states, is more heavily urban land use which may have a more direct impact on the Pawcatuck mainstem water quality. There are several large agricultural areas in the watershed adjacent to the Pawcatuck River in North Stonington (Figure 7).

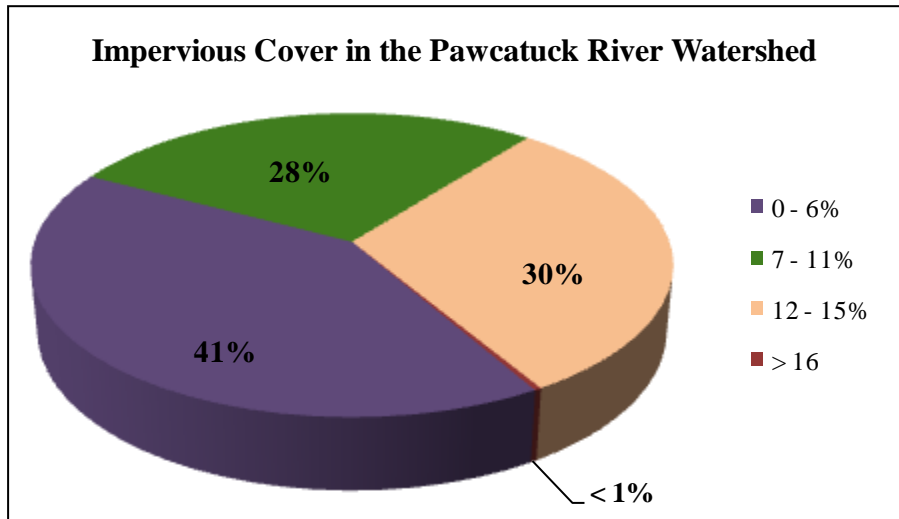
Figure 16: Range of impervious cover (%) in the Pawcatuck River watershed (CT)

The watershed is characterized by four impervious cover percentage ranges. The majority of the watershed (41%) is characterized by land with 0 to 6% impervious cover, while 28% of the land has 7 to 11% impervious cover, and 30% of the land is covered by 12 to 15% impervious. Less than 1% of the watershed is characterized by >16% impervious cover (Figure 16). Given the amount of impervious surfaces in the watershed and the proximity of those surfaces to the impaired segments, stormwater is a potential source of bacterial contamination to the Pawcatuck River and its tributaries and estuary.

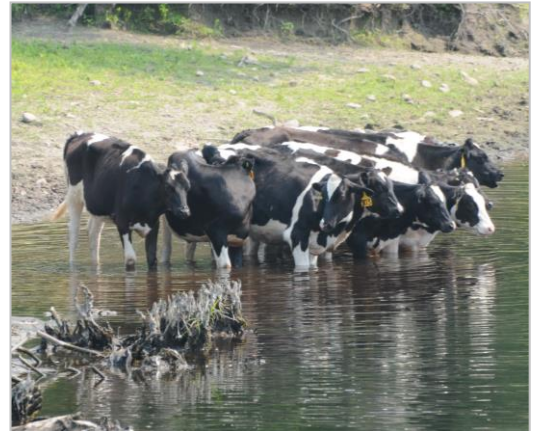
Figure 18. Cattle in Pawcatuck River at Boom Bridge Road Station 17620

There is a very large agricultural area off Anthony Road and Boom Bridge Road in North Stonington. As shown in Figure 12, this area is adjacent to the Pawcatuck River and has between 1-500 head of cattle as delineated in ARCGIS. This area has also been identified in Figure 12 as a potential source of bacterial contamination from agricultural wastewaters and contaminated stormwater runoff. Figure 18 shows evidence that agriculture is likely creating some inputs of bacteria loading to the river.

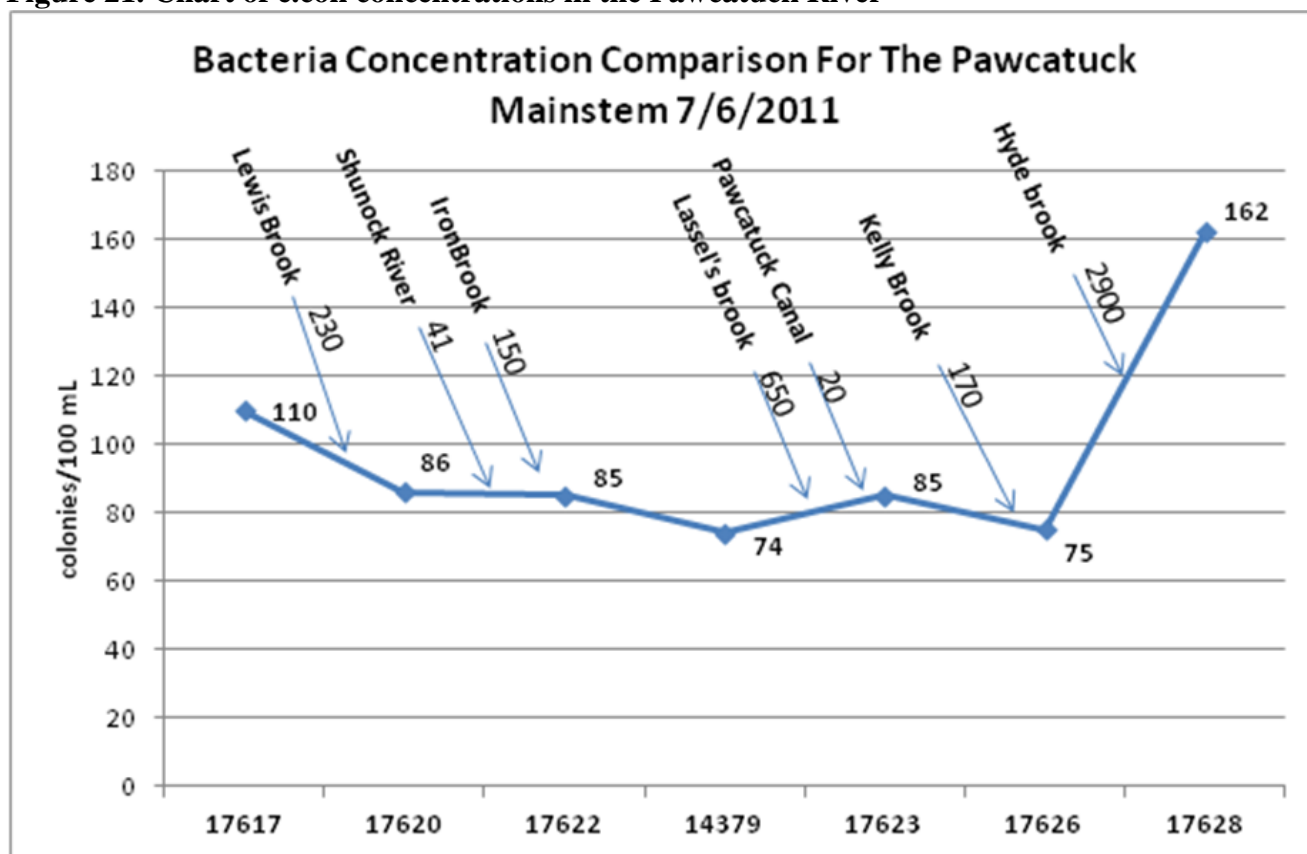
Figure 21. Chart of e.coli concentrations in the Pawcatuck River

The resulting values are the number of e.coli colonies per second at a sampling location on a sampling trip date. One set of dry weather data and one set of wet weather data was analyzed with this process. Data was analyzed using MS Excel spreadsheet formulas. The resultant charts are included in this appendix for the TMDL document. One additional chart has been included that shows direct colony count concentrations at the same locations and sample date as the dry weather bar chart (7-6-2011).

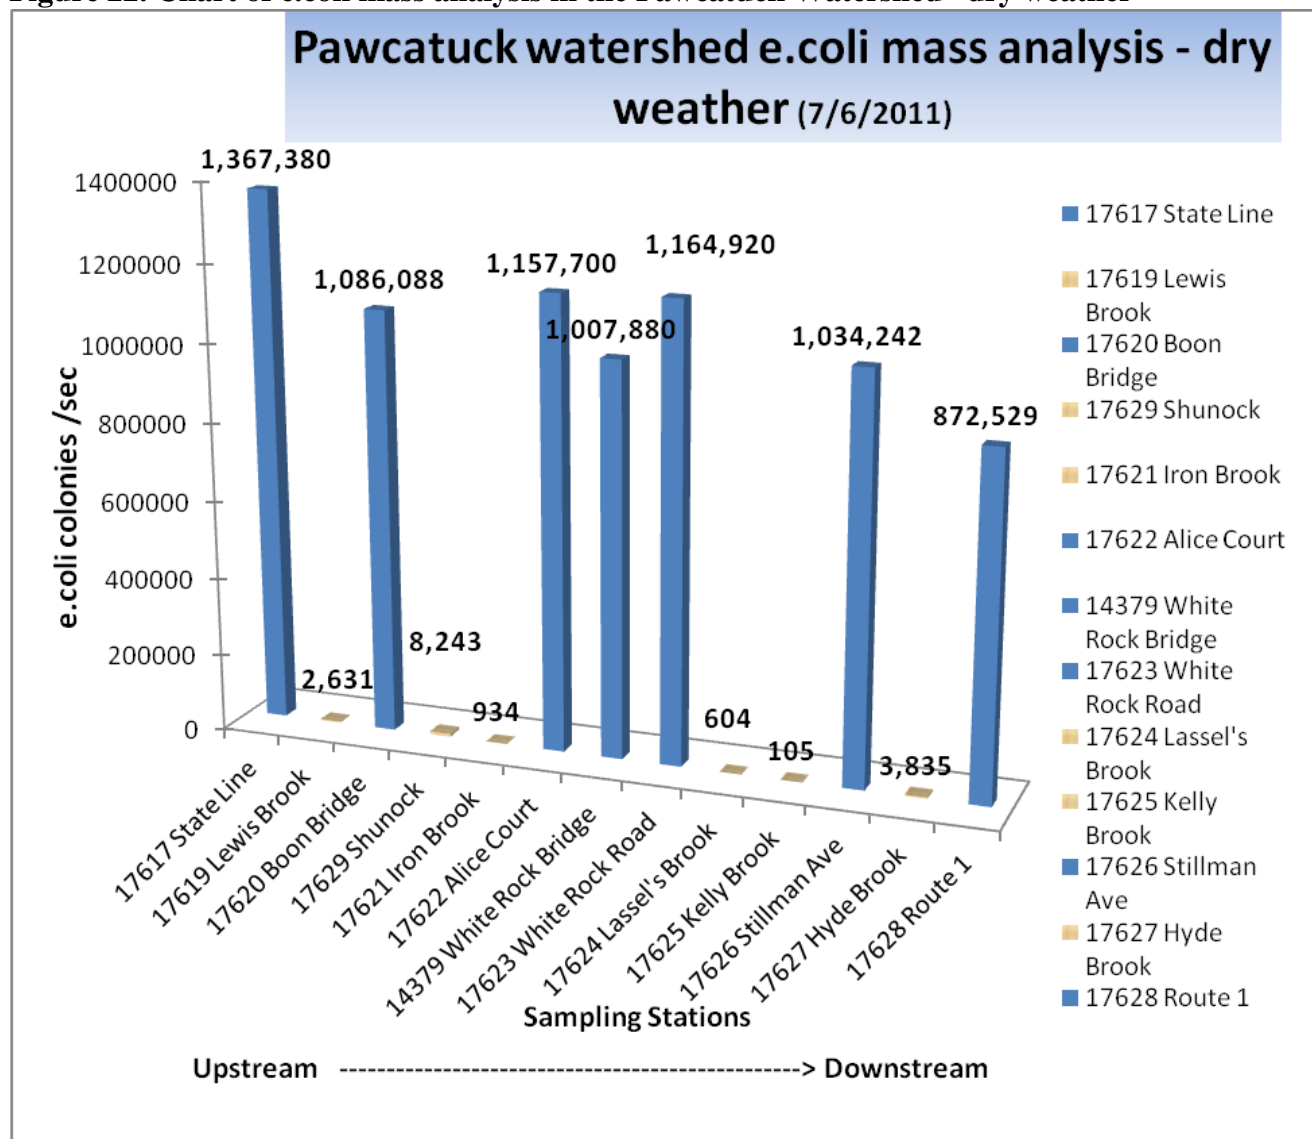
The line graph shows e.coli results on stations along the mainstem of the Pawcatuck River. Station 17617 is the most upstream station at the State border and station 17628 is at Route 1 at the Westerly and Stonington border. All tributaries point towards the location where they enter the Pawcatuck River as the

river flows towards Long Island Sound. Colony count concentrations for the tributaries are included on the arrows. By only reviewing the concentration data for the tributaries, which show larger concentrations than the mainstem, it would appear that a significant source of bacteria load is from these smaller streams. In fact the largest concentration collected on 7/6/2011 came from Hyde Brook with 2900 cols/100mls. Adding in the factor of flow volumes, paints a dramatically different picture of the same data.

Figure 22. Chart of e.coli mass analysis in the Pawcatuck Watershed –dry weather

When the flow volumes are added into the equation, the loading of the tributaries is shown to be a minimal input. In the above graph, the blue bars are representing the mainstem Pawcatuck stations and the beige stations are the tributaries. The values are for number of e.coli colonies per second at each sampling station. The graph moves from upstream to downstream in a left to right pattern. Station 17617 is located at the State border with Rhode Island. This location can be used to represent water quality in the river as it flows into Connecticut. During dry weather flows the mainstem of the Pawcatuck exhibit very large loads of bacteria in comparison to the tributaries. The first site in Connecticut has the largest load of bacteria on the chart. These loads are not a surprise as Rhode Island is also issuing TMDLs for their portions of the Pawcatuck River. While Connecticut doesn't utilize mass based criteria, this analysis is

very useful in determining where implementation efforts may have the most impact on the mainstem of the Pawcatuck River. While the loads of each tributary are much smaller than the mainstem, each tributary is impaired for e.coli bacteria and have received reduction goals in this TMDL document.
