THE MASSACHUSETTS ESTUARIES PROJECT

BACTERIA TMDL FOR MUDDY CREEK

Report # MA96-51-2004-01

Chatham & Harwich Massachusetts Cape Cod Watershed

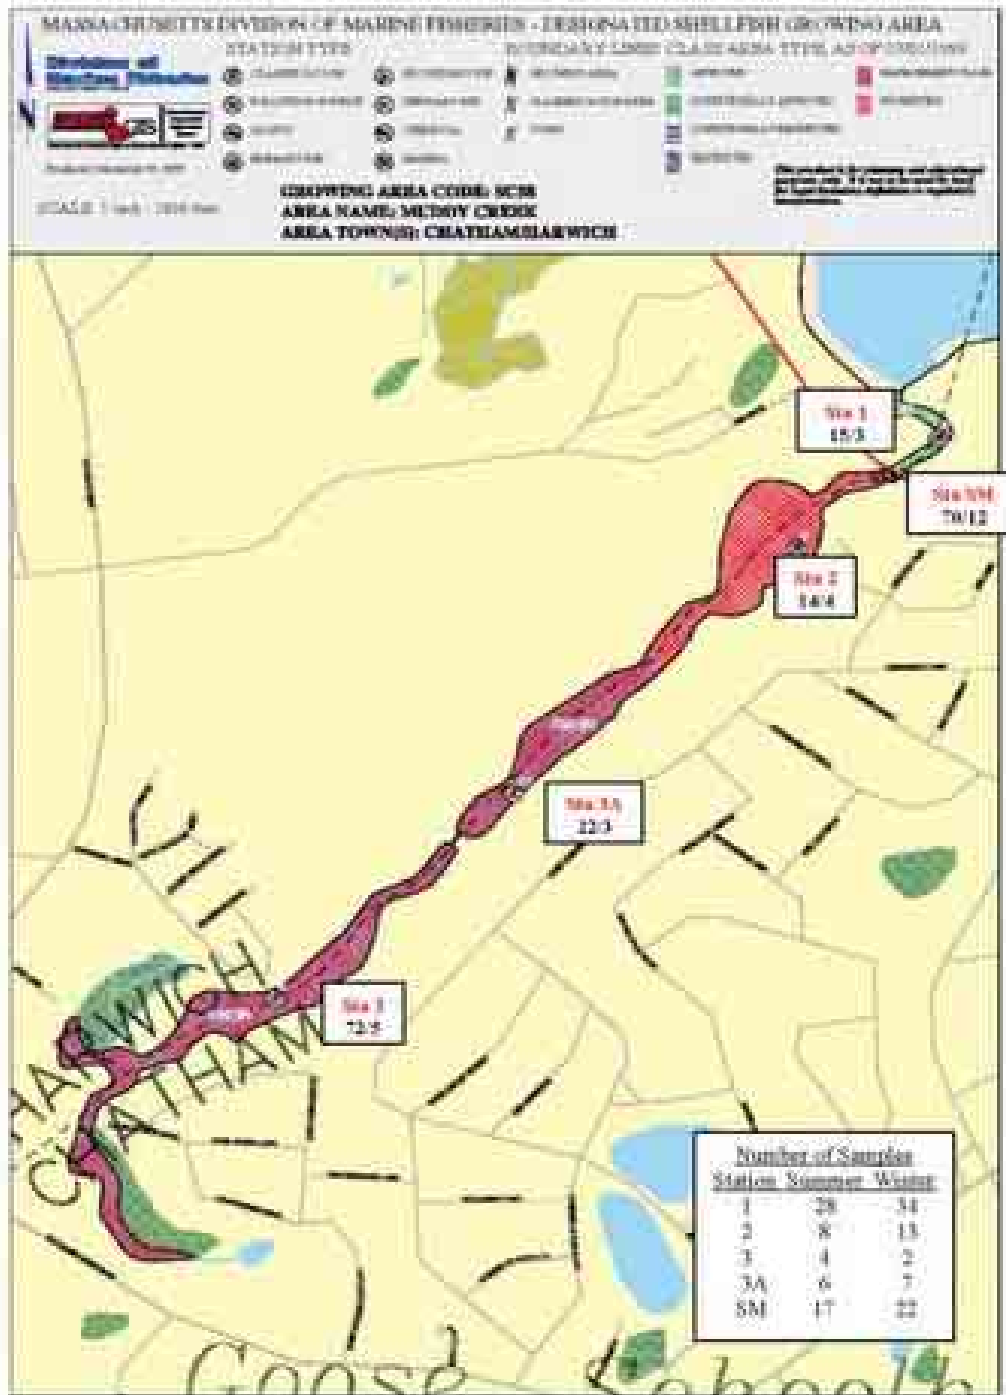
Figure V-2 Summer and winter fecal coliform bacteria counts (CFU/100 mLs), 1996-2003

Numbers indicate geometric means for summer/winter samplings by Massachusetts Division of Marine Fisheries, Town of Chatham Water Quality Department and SMAST (SM).

In the 1996-2003 sampling period, a total of 78 fecal coliform samples were taken at all stations during the winter. All geometric means were lower than the water quality standard of 14 and were significantly lower than summer means, ranging from 3 CFU/100 mL at Stations 1 and 3A to 12 CFU/100 mL at Station SM (Figures 2, V-4b, Table V-2a). Only at Station SM were more than 10% of the samples greater than the water quality standard of 43 CFU/100 mL (Table V2a). The ratio of summer to winter geometric means ranged from 3.2 at Station 2 to 13.7 at Station 3, indicating that *fecal contamination in the summer was approximately 3-14 times higher than the winter*.

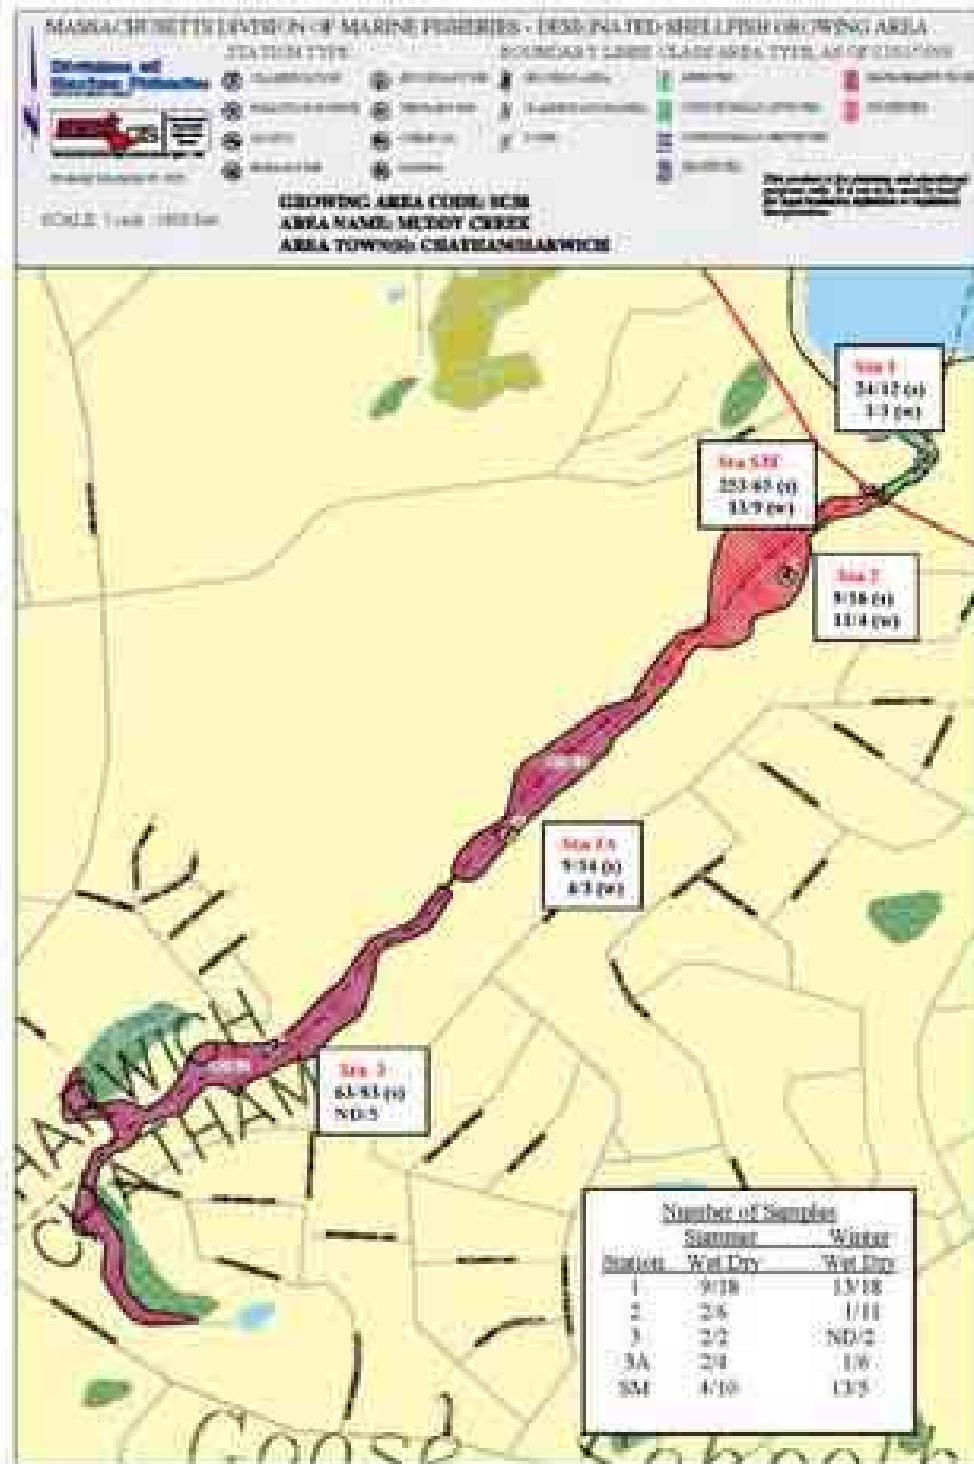
Figure V-3 Wet and Dry fecal coliform bacteria counts (CFU/100 mLs), 1996-2003.

Numbers indicate geometric means of wet/dry data for summer (s) and winter (w) samplings by DMF, Town of Chatham and SMAST.

Given the temporal distribution and number of samples during the years 1996-2003, it was possible to evaluate wet versus dry weather bacterial levels. Samplings were separated into wet and dry events based on the total rainfall for the 3 days prior to sampling (dry weather < 0.25 inches of rainfall > wet weather). A total of 19 wet samples and 40 dry samples were taken during the summer for fecal coliform. A total of 28 wet and 42 dry samples were taken during the winter (Figure V-3, Table V-2a). For the summer, wet geometric means ranged from 9 CFU/100 mL at Stations 2 and 3A to 253 CFU/100 mL at Station SM. Dry means ranged from 12 CFU/100 mL at Station 1 to 83 CFU/100 mL at Station 3 (Figures V-3 and V-6a). Wet means exceeded the water quality standard of 14 CFU/100 mL at Stations 1, 3 and SM. Dry means exceeded the standard at Stations 2, 3, 3A and SM (Table V-2a). More than 10% of samples at all stations for both wet and dry sampling were above the water quality standard of 43 CFU/100 mL (Table V-2a). The ratio of wet to dry geometric means ranged from 0.3 at Station 3A to 3.9 at SM. *Wet inputs were significantly greater than dry inputs at Stations 1 and SM only.* These results indicate that non-runoff sources are the dominant players in the upper basin and upper portion of the lower basin (Stations 2, 3, and 3A) and that runoff is a dominant player in the region of the tidal inlet and Route 28 (Stations 1 and SM).

For winter samplings, wet weather geometric means ranged from 3 CFU/100 mL at Station 1 to 13 CFU/100 mL at Station SM (there were no samples taken at Station 3 and only single samples were taken at Stations 2 and 3A). Dry geometric means ranged from 3 CFU/100 mL at Station 1 to 9 CFU/100 mL at Station SM (Figures V-3, V-6a, V-6b, Table V-2a). *In the winter, none of the geometric means for wet or dry samples exceeded the water quality standard of 14 CFU/100 mL and only at Station SM for both wet and dry samplings did more than 10% of samples exceed the water quality standard of 43 CFU/100 mL* (Table V-2a). Ratios of wet to dry means ranged from 1.2 at Station 1 to 2.9 at Station 2, indicating that wet bacterial inputs during the winter were 1-3 times dry inputs (Table V-2a). These results support the source indications found in the summer analysis, above.

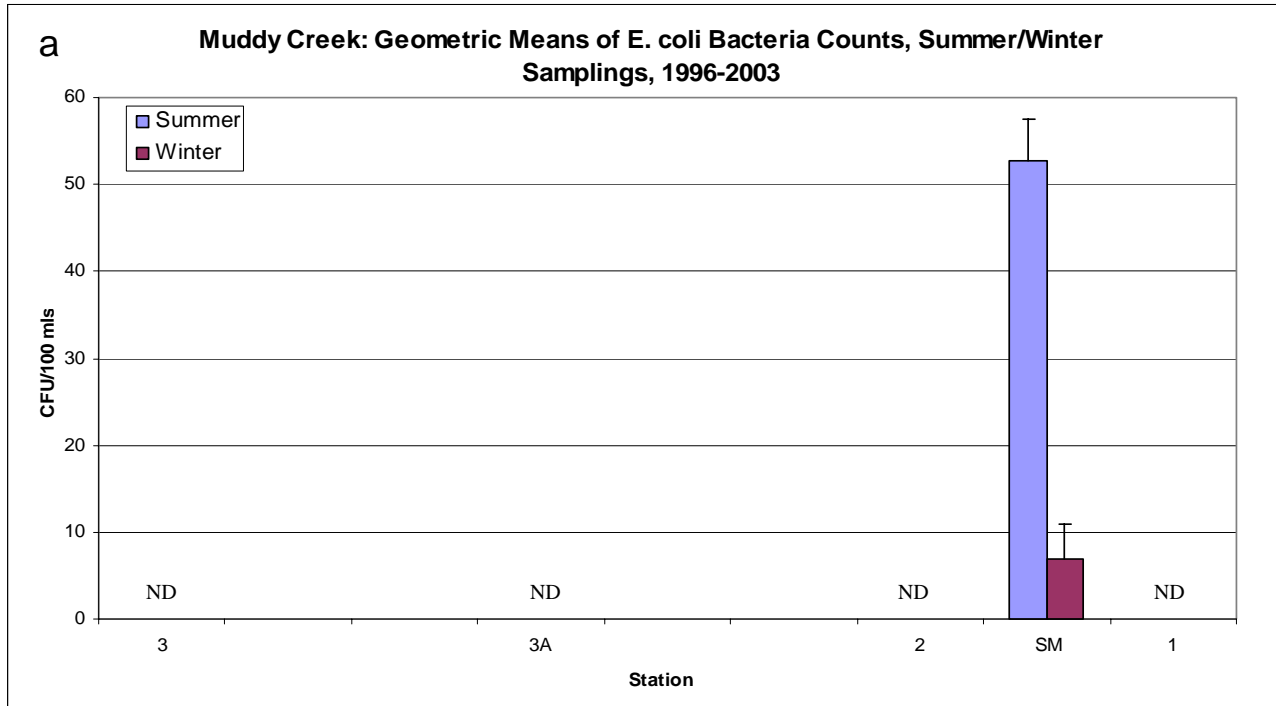
Figure V-5 Summer and winter *E. coli* (a) and *Enterococcus* (b) bacteria counts (CFU/100 mls) during the years 1996-2003. Numbers indicate geometric means for summer/winter samplings by SMAST (SM).

For E. coli, there were 4 wet and 10 dry samples in the summer, and 13 wet and 5 dry samples from the winter at Station SM. The summer wet weather geometric mean was 159 CFU/100 mL, while the dry mean was 56 CFU/100 mL. Both means exceeded the water quality standard of 43 CFU/100 mL and more than 10% of the samples exceeded the water quality standard of 43 CFU/100 mL (Table V-3b). The wet mean to dry mean ratio was 2.8, indicating that *wet inputs were approximately 3 times higher than dry inputs in the summer*. The winter wet and dry geometric means at Station SM were 7 CFU/100 mL. Neither exceeded the water quality standard and only the wet samples had more than 10% above the water quality standard of 43 CFU/100 mL. *The wet mean to dry mean ratio at SM for the winter was 1.0, indicating that wet and dry inputs were equivalent* (Table V-3b).

For *Enterococcus*, there were 4 wet and 10 dry samples in the summer and 4 wet and 5 dry samples in the winter. The summer wet mean at Station SM was 119 colonies/100 mL and the dry mean was 51 colonies/100 mL for a wet mean to dry mean ratio of 2.3, *indicating that wet inputs were approximately 2-3 times greater than dry inputs in the summer and both weather conditions exceeded the water quality standard of 35 colonies/100 mL*. Seventy-five per cent of the wet samples in the summer and 40% of the dry samples exceeded the water quality standard of 104 (Table V-3c). The winter wet mean was 8 colonies/100 mL and the dry mean was 12 for a wet mean to dry mean ratio of 0.7, indicating that wet inputs in the winter were slightly less than dry inputs (Table V-3c). Neither mean exceeded the water quality standard of 35 and 8% of the wet samples exceeded the water quality standard of 104 colonies/100 mL.
