# **TOTAL MAXIMUM DAILY LOAD STUDY FOR BACTERIA MOUNT HOPE BAY AND THE KICKEMUIT RIVER ESTUARY**

**State of Rhode Island  
Department of Environmental Management  
Office of Water Resources  
Surface Water Protection Section**

Final to EPA  
December 2009

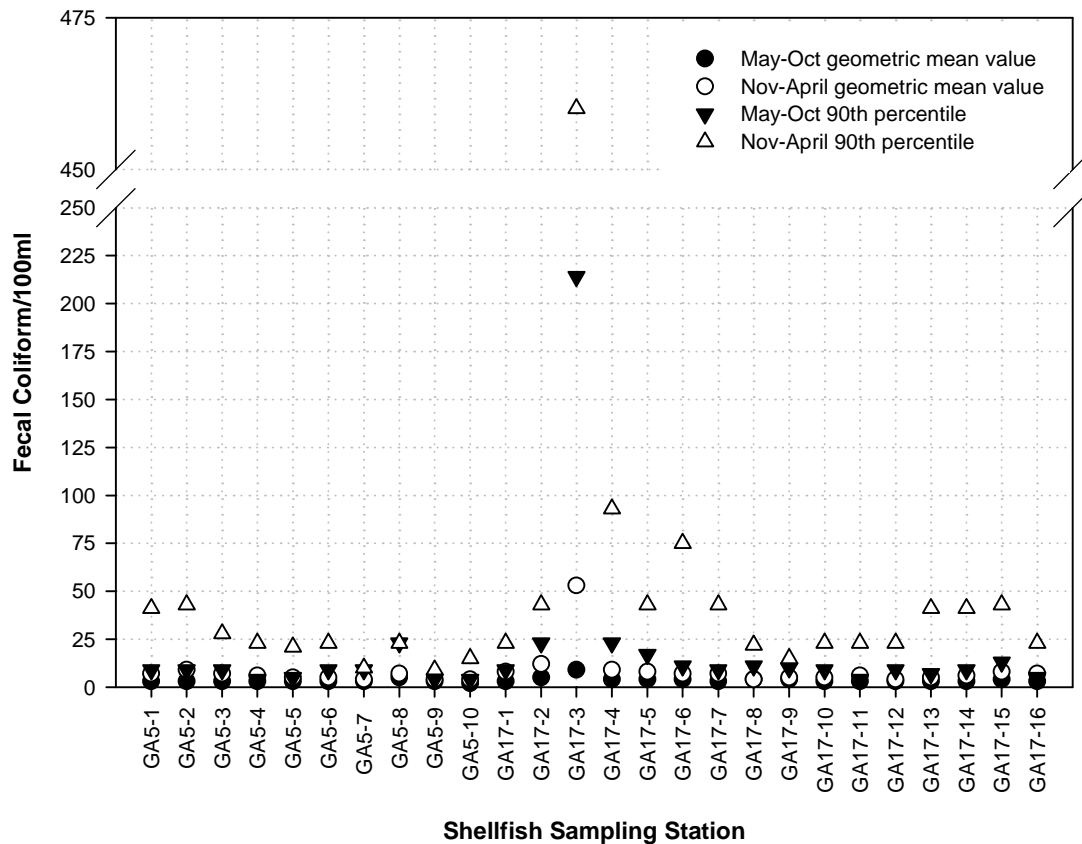
Addressing seasonal variations is an important and required component of TMDL development. Routine monitoring data are available throughout the year, therefore if a seasonal component exists, it should be discernable from analysis of this data. Figure 5.1 displays geometric mean and 90<sup>th</sup> percentile values calculated from five years (2003-2007) of shellfish sampling data collected at ambient stations in Mount Hope Bay and the Kickemuit River. Dark symbols represent those samples collected during the May-Oct timeframe while open symbols represent data collected between November and April.

**Figure 5.1 Seasonal analysis of fecal coliform bacteria data in Growing Areas 17 and 5.**

The most elevated levels of bacteria concentrations in Mount Hope Bay and the Kickemuit River are reflected in the winter (Nov-April) 90<sup>th</sup> percentile statistics. As shown in Figure 5.1 the greatest variability in fecal coliform bacteria concentrations in both the Kickemuit River and Mount Hope Bay occurs during the winter (April-Nov) period. The reason(s) for this is unclear but may be due, in part to factors contributing to fecal coliform die off, such as solar radiation and temperature. Regardless of the seasonal differences, for the most part, all ambient stations in both growing areas meet shellfishing criteria during dry weather. Furthermore, wet weather conditions occur during all seasons. Therefore it was determined that seasonality was not an issue in terms of developing the TMDL.

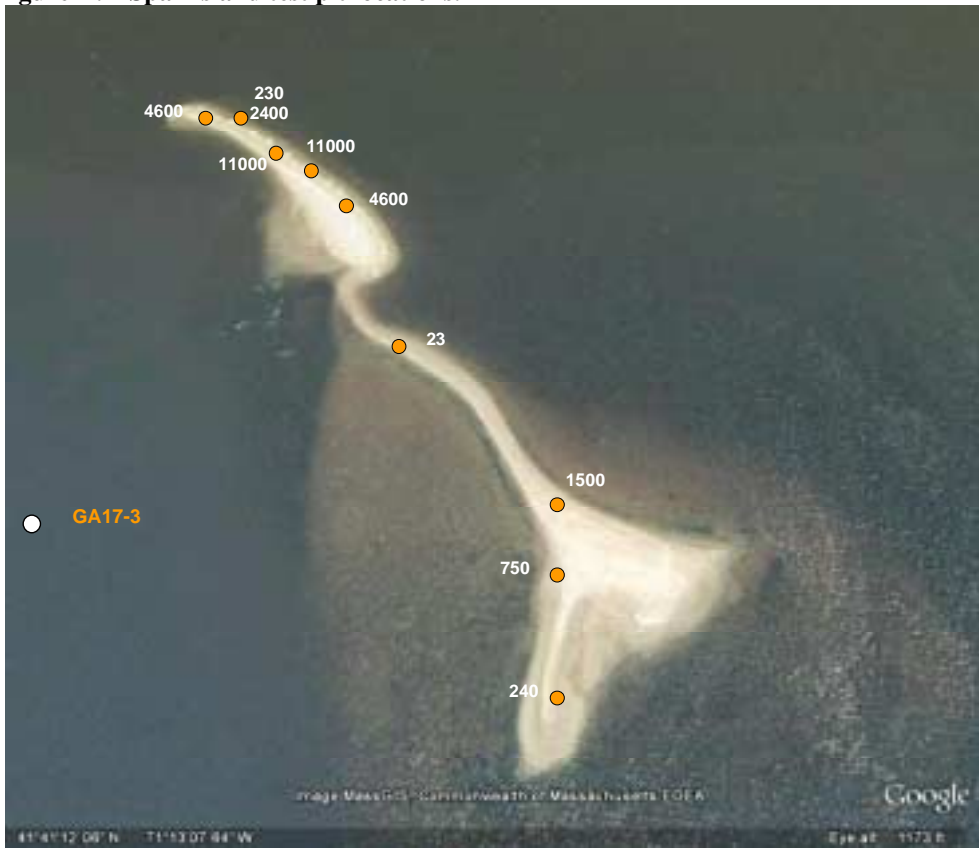
**Figure A.1 Spar Island test pit locations.**
